MISCELLANEOUS PAPER GL-81-8

EVALUATION OF MEMBRANE INTERLAYERS FOR PREVENTION OF CRACK REFLECTION IN THIN OVERLAYS

Philip J. Vedros, Jr.

October 1981

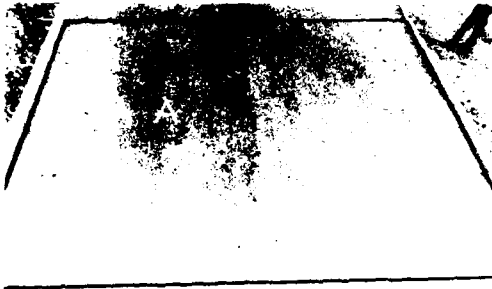
Photo 9. Bidim C-22 fabric section, south side of Faith Avenue

10. The cracking on Faith Avenue before application of the test materials was minor and tended to be localized. The cracks were sealed before application of the test materials (Photo 8). No measurement of the length of the cracking in each photographic test area was made of the original pavement before application of the test materials. The original cracking pattern can be seen in Photos 9 through 18. The first evidence of any cracking in the overlay on Faith Avenue was observed in February 1978. A fine hairline crack in the Mirafi 140 section on the southside was determined to be caused by a wrinkle in the fabric during construction (Photo 19). A reflection crack in the control section on the north side of Faith Avenue was observed in May 1978 (Photo 20). Table 1 presents a summary of the estimated percentage of reflection cracking that was observed in all test areas on Faith Avenue. As noted, the only sections that had cracking were the two sections of the Mirafi 140 fabric and one control section.

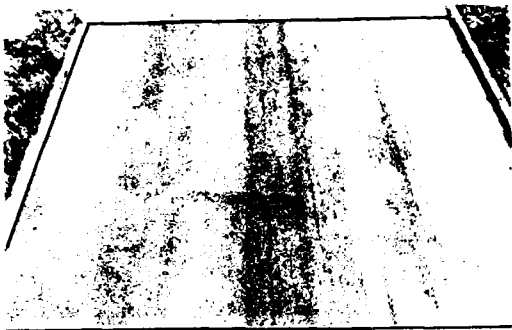
Photo 13. Mirafi 140 fabric section, south side of Faith Avenue

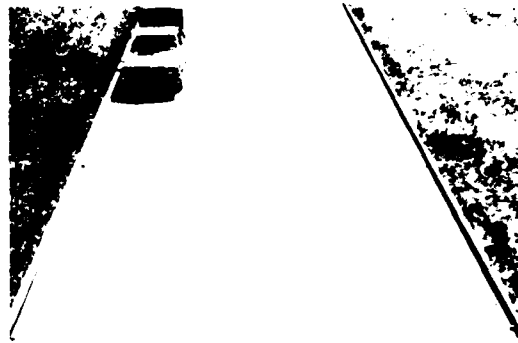
Photo 15. Mirafi 140 fabric section, north side of Faith Avenue

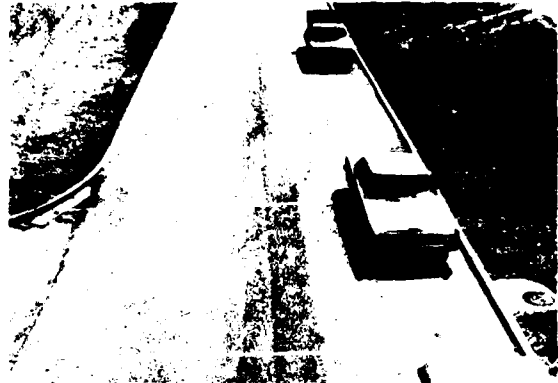
Photo 17. Bidim C-22 fabric section, north side of Faith Avenue

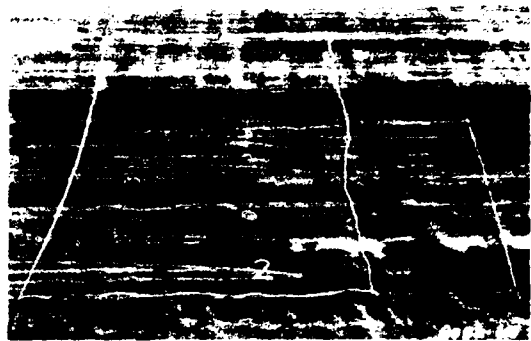
12. The cracking in the pavement surface on this runway appeared to be typical reflection cracking from soil-cement base material. All cracks on the NW-SE runway had been sealed in 1973, but the cracks that developed since that time had not been sealed at the time of these tests. The unsealed cracks ranged in width from 1/4 to 1/2-in. About 20 percent of the cracks were unsealed in the selected test locations. As shown in Figure 2, there were six test sections on the NW-SE runway with two of the sections used as a control. Photos 21 through 26 indicate the crack pattern that existed in the selected photographic areas before placement of the test materials and the progression of reflection cracking through the materials at the end of the last inspection in June 1981. Table 2 presents a summary of the percentage of cracking

Photo 22. Control section, NW-SE runway-station 19+50 to 21+50

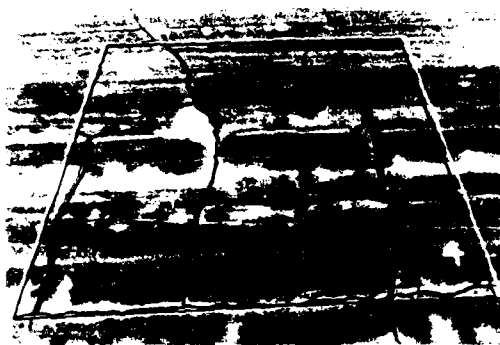
Photo 24. Mirafi 140 fabric section, NW-SE runway

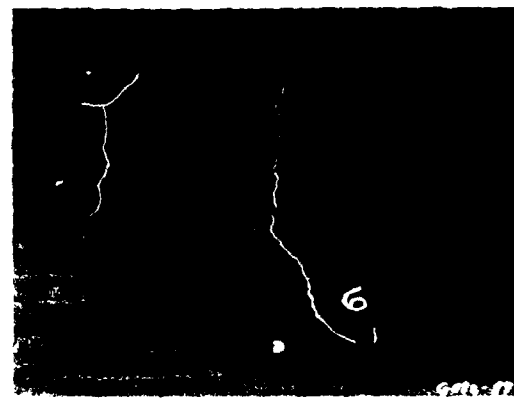
that has reflected over the 4-year period the sections were monitored. Sections 1 through 6 were located on the NW-SE runway. Table 3 indicates the percentage of cracks for each area of the airfield and roadway. As noted in Table 3, the U. S. Rubber section indicated the lowest crack reflection at 44.8 percent and the Sahuaro rubber the highest at 88.8 percent.

Photo 26. Sahuaro rubber section, NW-SE runway

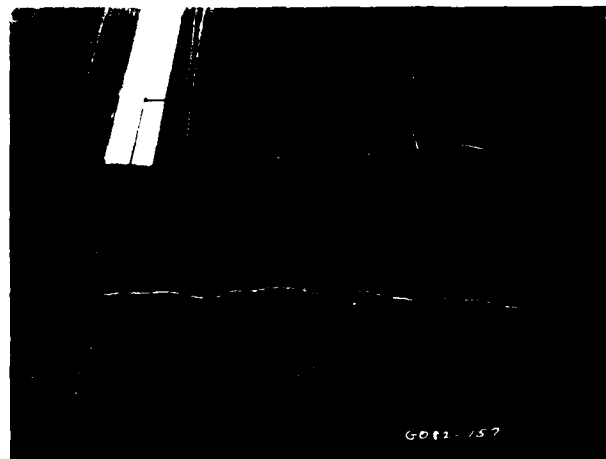
13. The cracking in the pavement surface on this runway was not as severe and numerous as on the NW-SE runway. The cracks were generally about 1/4-in. in width and had never been sealed. Sections numbered 7 through 12 are located on this runway. Photos 27 through 32 indicate the crack pattern that existed in the selected photographic areas before placement of the test materials and the progression of reflection cracking with time. Table 2 indicates the percentage of cracking for Sections 7 through 12, and Table 3 summarizes the data for each facility. As noted in Table 3, the control section indicated the lowest crack reflection at 53.3 percent, and the Mirafi 140 fabric the highest at 97.0 percent.

Photo 28. Control section (south), N-S runway

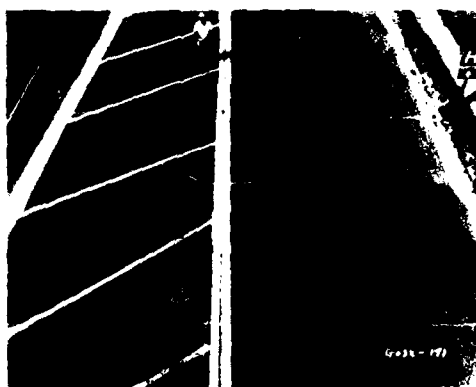
Photo 42. Control section, Barnum Road

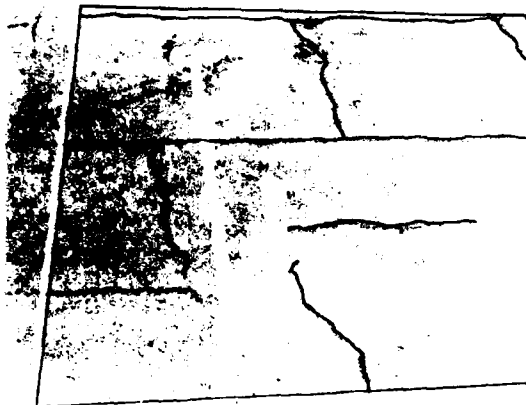
were the result of reflection from cracks in the underlying pavement. As noted in Table 4, the Sahuaro rubber section indicated the lowest crack reflection at 1.0 percent, and the Mirafi 140 fabric the highest at 56.9 percent. The existence of the tar slurry seal on the surface made it difficult to determine whether a fine hairline crack was a reflection crack or not. The tar seal has a characteristic of having numerous fine hairline cracks in a chicken wire pattern. The east apron was overlaid in 1976 using a keystone course with the 1-1/2 in. of asphaltic concrete, and it was noted during the inspection in June 1981 that reflection cracks are beginning to appear in the pavement surface of the east apron.

Photo 43. Sahuaro rubber section, south end of west apron

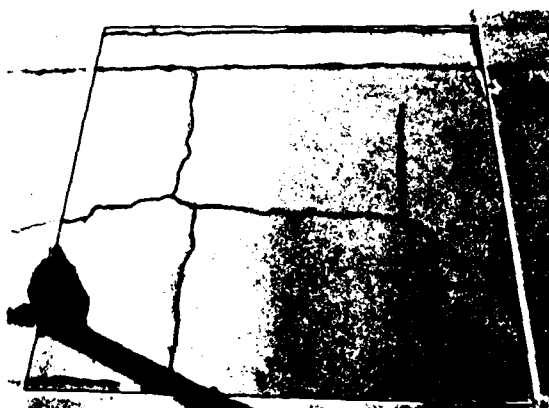
Photo 46. U. S. Rubber section, north end of west apron

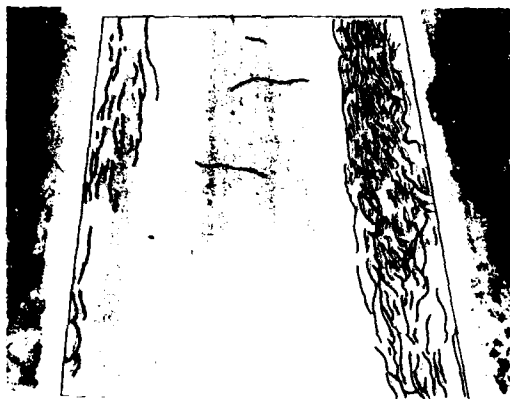
Photo 59. Petromat fabric section, south end of Wilderness Road

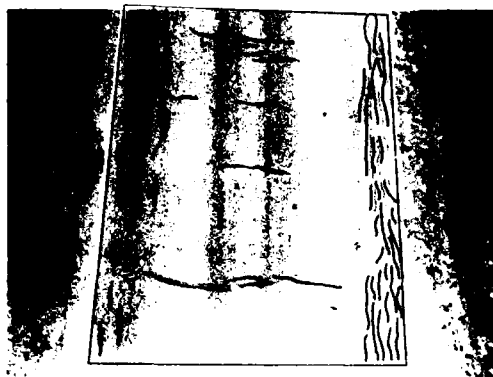
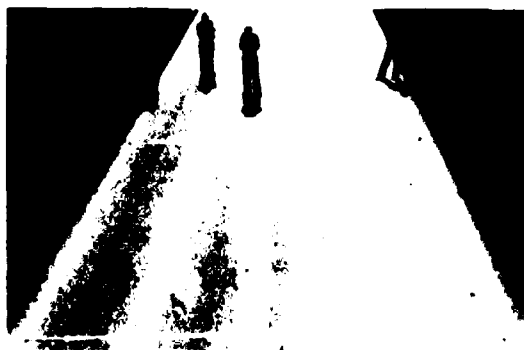
Photo 61. Bidim C-22 fabric section, south end of Wilderness Road

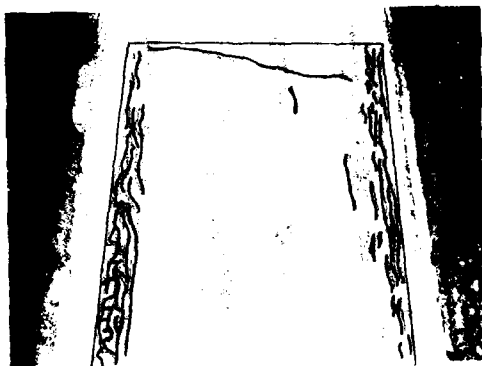
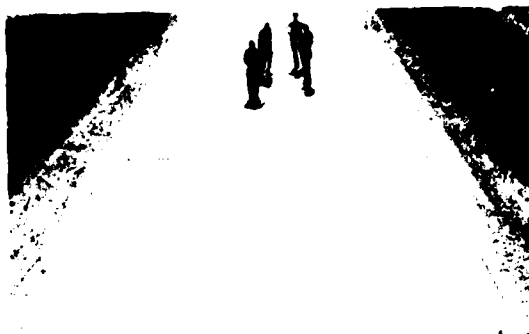
Photo 62. Sahuaro rubber section, south end of Wilderness Road

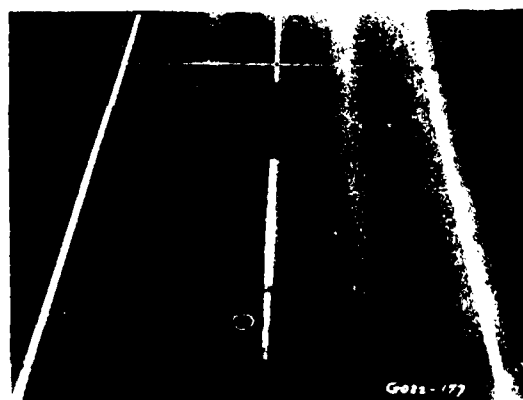
Photo 63. Control section, south end of Wilderness Road

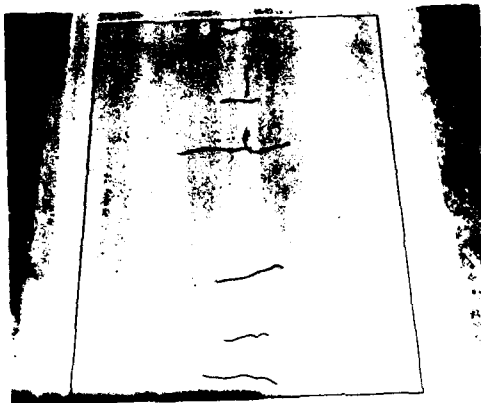
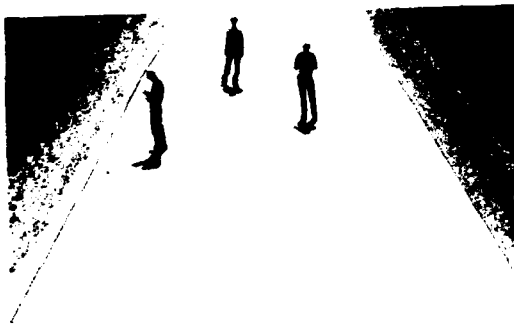
Photo 65. Mirafi 140 fabric section, north end of Wilderness Road

- b. Use of a very firm fabric, such as Mirafi 140, will cause problems under thin overlays from wrinkles, if permitted during placement. The wrinkles in the softer fabrics, such as Bidim and Petromat, did not affect the performance of the materials under a thin overlay.

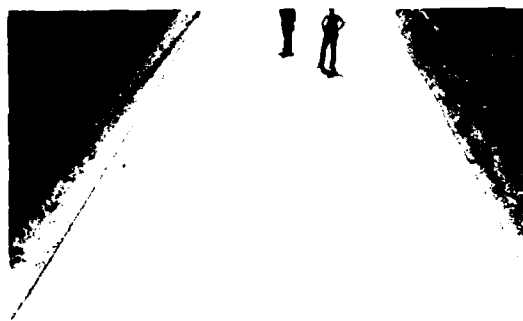
Photo 66. Bidim C-22 fabric section, north end of Wilderness Road

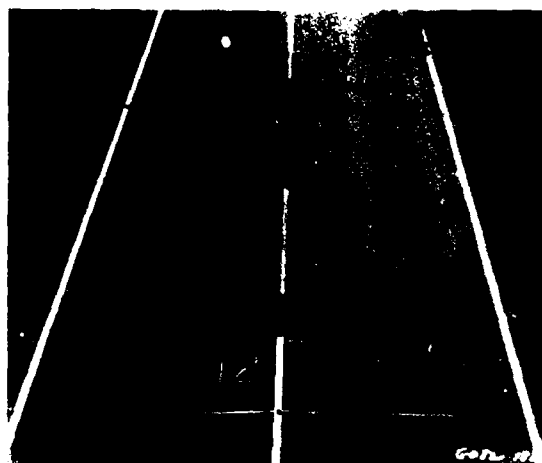
Photo 69. Control section, north end of Wilderness Road
